**American Patriot
Home Inspection**

**1234 Anywhere St.
USA, TX 12345**

PROPERTY INSPECTION REPORT

By: Rodney W Collette, Lic #20449 03/26/2014
(Name and License Number of Inspector) (Date)

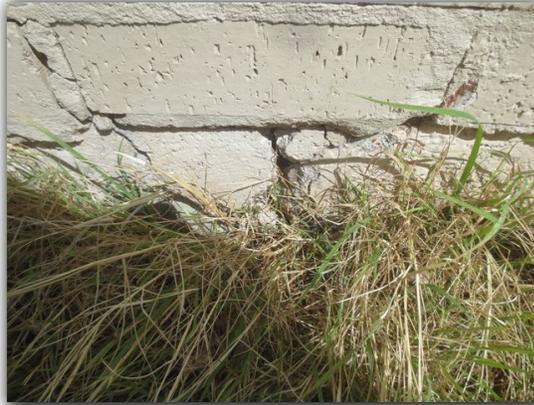
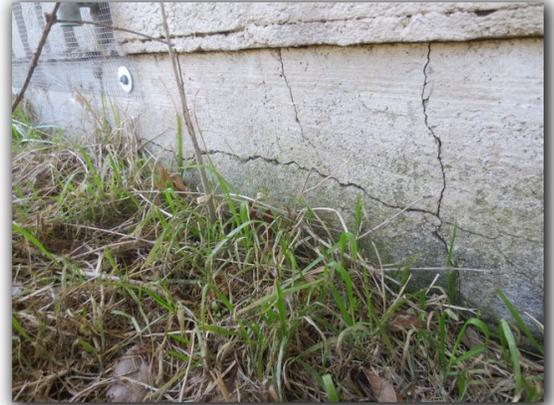
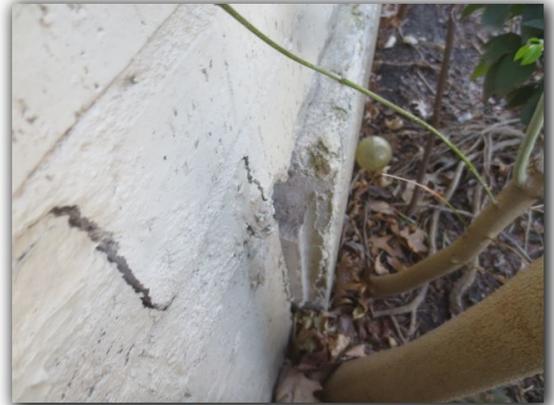
- Floor slopes and/or unlevelness observed.
- Foundation rebar is visible at the edge of the foundation beam on the south side of the house and needs to be properly covered.

- Substantial foundation cracking was observed in various locations. This implies that some structural movement of the building has occurred. The rate of movement cannot be predicted during a one-time inspection. A professional foundation repair company or a structural engineer should be consulted to further evaluate this condition.

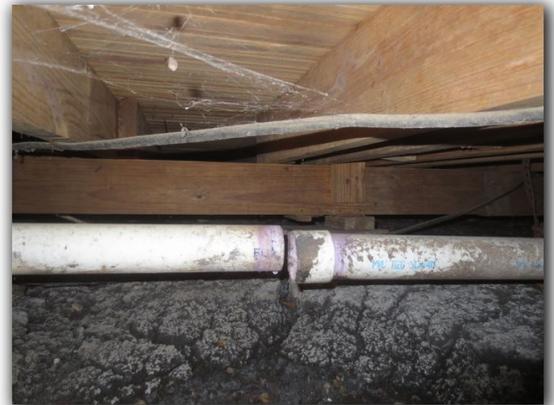
- There was evidence of moisture and water ponding observed in the crawl space under the house. This should be further investigated and repairs made as necessary.

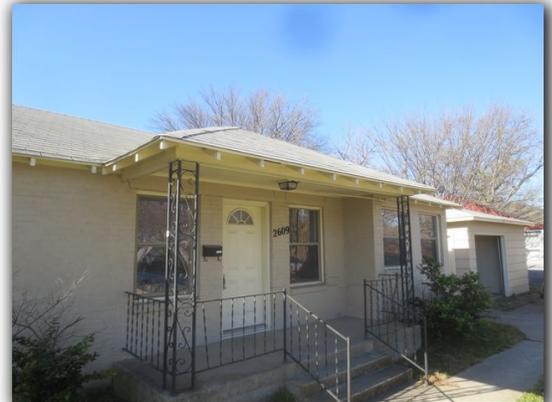
- Negative site drainage was observed in various locations. The general topography of the area is such that it may be difficult to control storm water entirely. During heavy rains the accumulation of storm water on the lot may be unavoidable. Proper drainage is needed to help prevent water from standing and/or ponding next to the foundation area. Under today's building standards, the grade away from the foundation walls should fall a minimum of six-inches (6") within the first ten feet (10ft.). If adding soil to the perimeter to create positive drainage, remember to keep the soil level about 4 inches BELOW any brick veneer and 6 inches below any wood or composite siding.

- In areas where expansive or collapsible soils are known to exist, all dwellings should have a controlled method of water disposal from the roof that will collect and discharge all roof drainage to the ground surface at least 5 feet from the foundation walls or to an approved drainage system. It is recommended that gutters be added around the roof structure to properly discharge water away from the foundation walls and to prevent erosion around the base of the foundation.

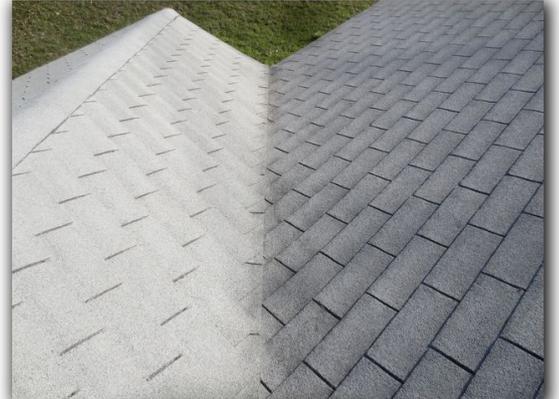
- The roofing is nearing the end of its life cycle. Replacement will become necessary in the near future and should be budgeted for. Minor repairs are recommended in the short term to maintain the weather tightness of the roof. Damaged or missing roofing material should be repaired or replaced. All roof penetrations should be examined and sealed as necessary. You are encouraged to have your insurance company and/or properly certified roofing contractor physically inspect the roof, prior to closing, to fully evaluate the insurability and condition of the roofing material.
- Composition shingle tab granules observed to be thinning in various locations. This should be monitored and repaired as necessary.

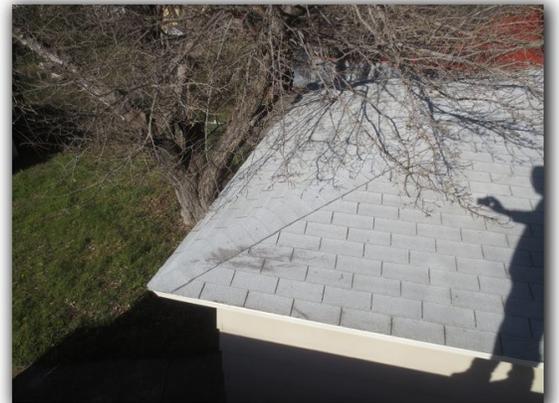
- Tree branches should be trimmed back from the roofing material to prevent damage and premature wear and tear on the shingles.

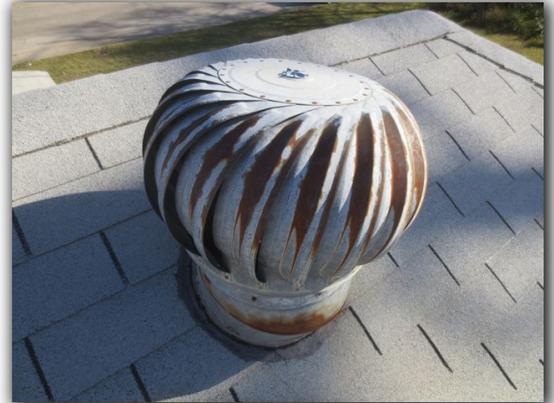
- The felt paper was observed to be installed under the lower metal drip edge flashing. The manufactures installation requires the felt paper to be installed over the top of the metal drip edge flashing in shingle like fashion to help prevent water intrusion and/or damage to occur behind the fascia board and soffit/eave areas. This is a condition that cannot be remedied at this time but when a new roof is applied attention should be paid to this detail.
- The roof level turbine was observed to be rusted at the time of this inspection. This should be monitored and repaired as necessary

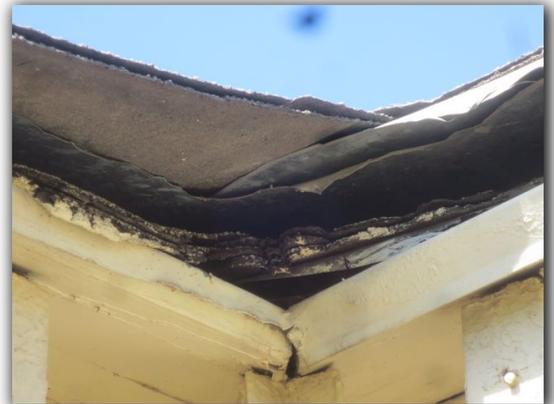
- Roof turbine is not functioning properly. This should be repaired to provide proper ventilation for the attic area.
- Two or more layers of composition roofing observed to be in place at the time of this inspection.

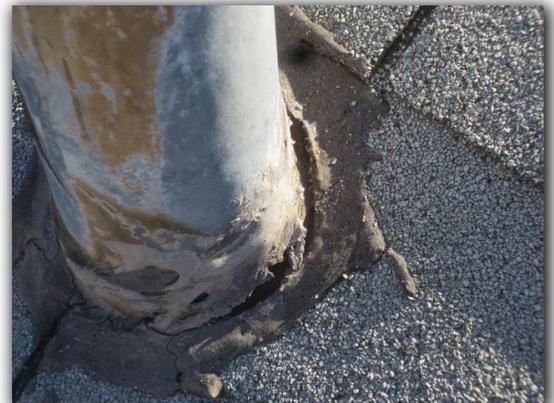
- Penetrations through roof need re-caulked to ensure no water intrusion.

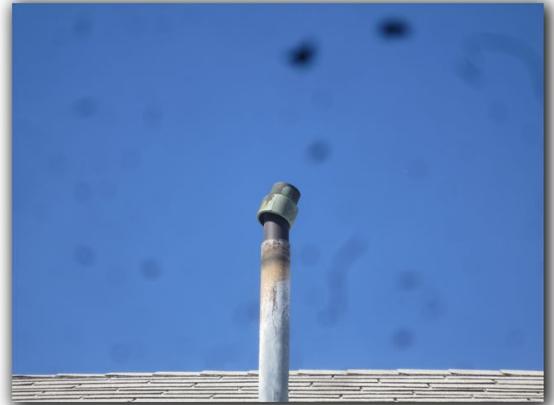
- The lead jack flashings on the roof need to be checked, reset and/or repaired as necessary. The lead jack flashing observed to be improperly damaged at one or more of the roof level plumbing vent pipes. The lead flashing should run full length of the vent pipe and turn down into the top of the vent pipe to help prevent water

intrusion at this point.

- The roof level plumbing jack flashing has some damage to the rubber protective seal around the stack. This should be repaired to prevent moisture from entering the attic around the plumbing stack.

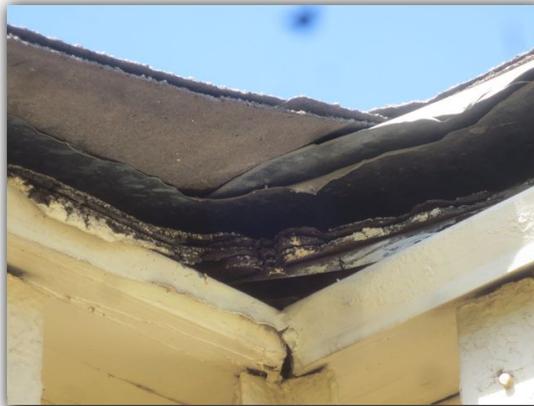
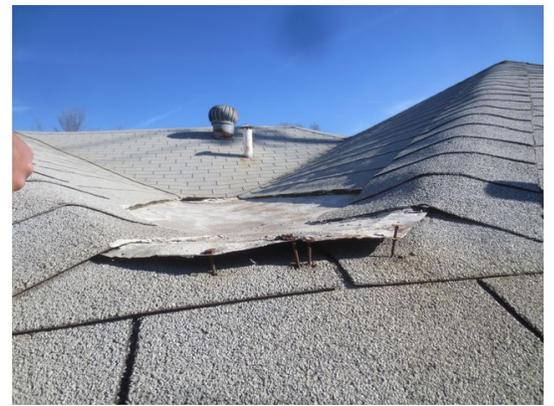
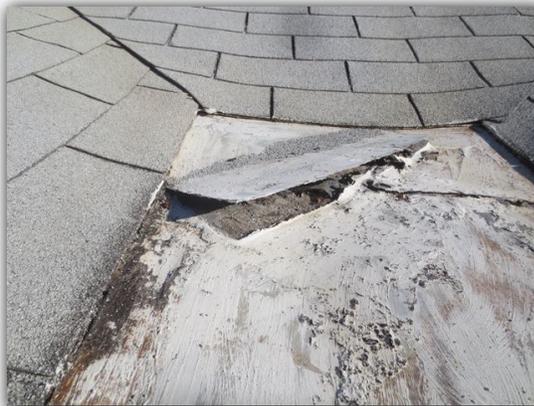
- Roof flashing was observed to be lifting and/or pulling loose in a couple of locations and should be re-secured to prevent moisture intrusion and damage to the underlying structure.

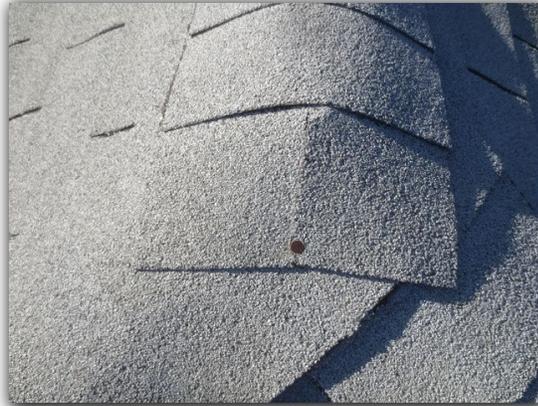
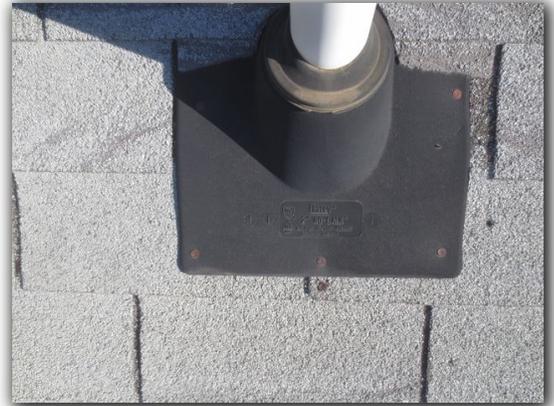
- Roof fasteners (nails and/or staples) were observed to be exposed in various locations and should be properly sealed at the ridge caps and flashing areas.

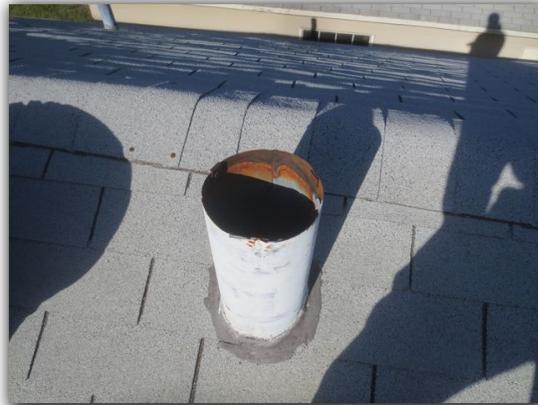
- Old furnace flue missing cap. Water able to go straight into attic.

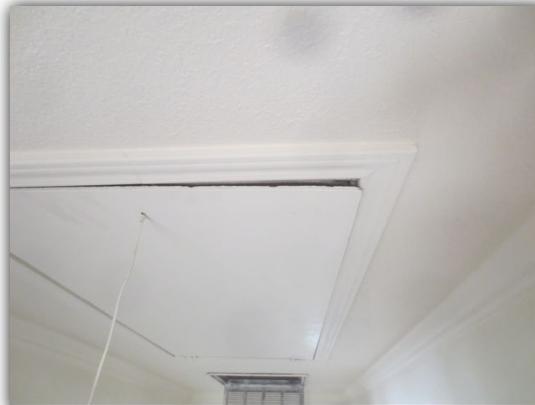
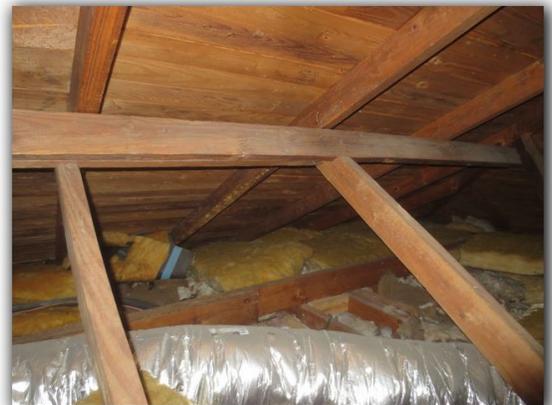
- Insulation improvements may be cost effective, depending on the anticipated term of ownership. Ten plus inches of insulation will provide an R-30 energy efficiency rating which would be adequate for this region of the country.
- The attic fold down door or the attic hatch should be insulated for better efficiency.
- The attic insulation has been placed over the fascia vents . This condition should be corrected to help improve the cross ventilation that is required for the attic space.

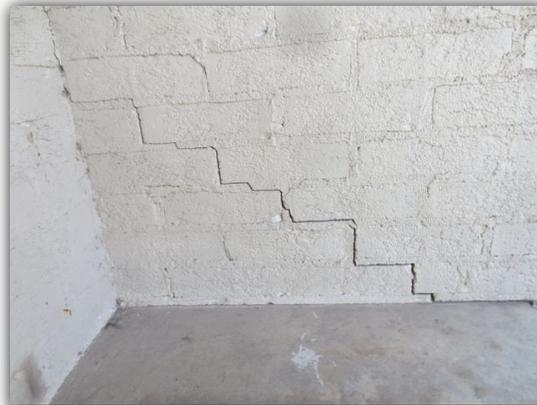
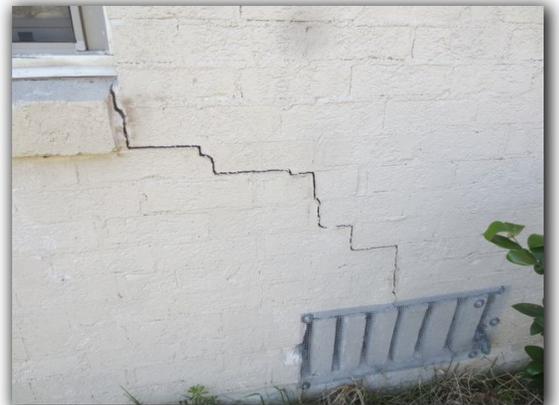
- Pronounced exterior wall cracks were observed in various locations . This implies that structural movement of the building has occurred. The rate of movement cannot be predicted during a one-time inspection. A professional foundation repair company or structural engineer should be consulted to further evaluate this condition.

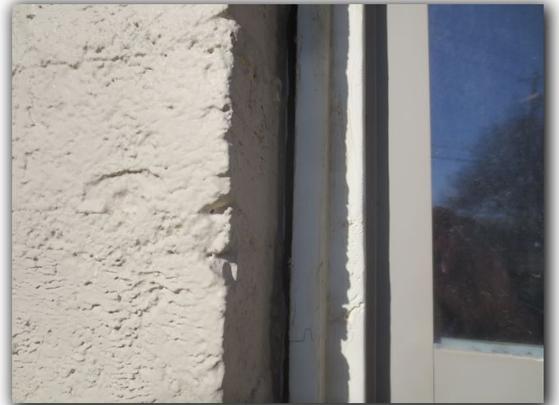
- Window trim was observed to be pulling away or separated from the exterior brick veneer in various locations. This could be an indication of movement in the structure and should be monitored for any further movement and repaired as necessary.

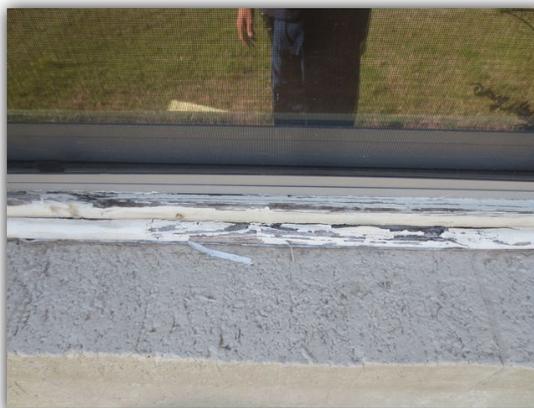
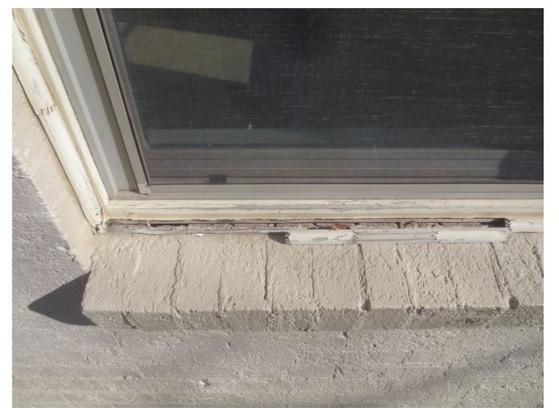
- Exterior wood trim was observed to have some deterioration and/or damage Various Locations. These areas should be repaired to prevent further moisture intrusion into the underlying structure.

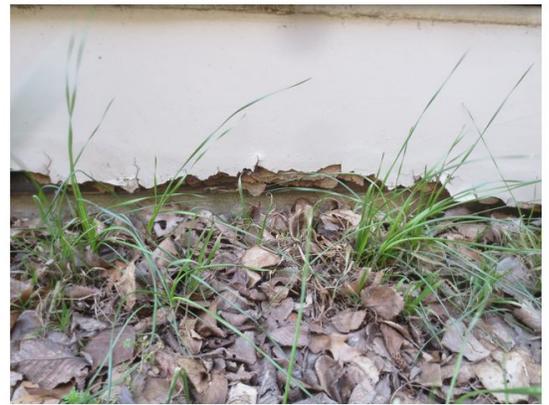
- Wood veneer was observed to have some deterioration and/or damage Various Locations. These areas should be repaired to prevent further moisture intrusion into the underlying structure.

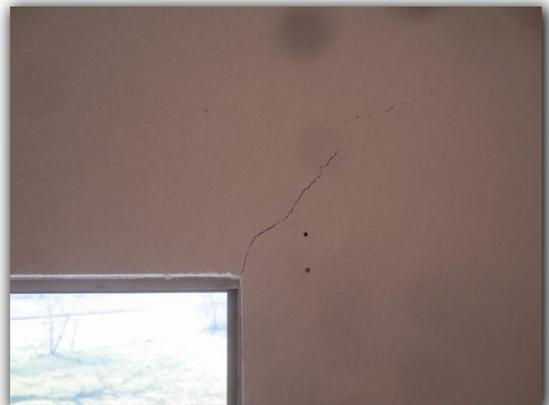
- Wood to soil contact at the base of the siding on garage and shed should be eliminated. Rotted or damaged siding that is uncovered should be repaired.
- The exterior masonry veneer has been painted which tends to hide visual defects and limits the inspector's visual observations.
- Larger than typical sheet rock cracks were noted [Various Locations](#). This condition could indicate greater than normal movement within the structure. This should be further investigated and repaired as necessary.

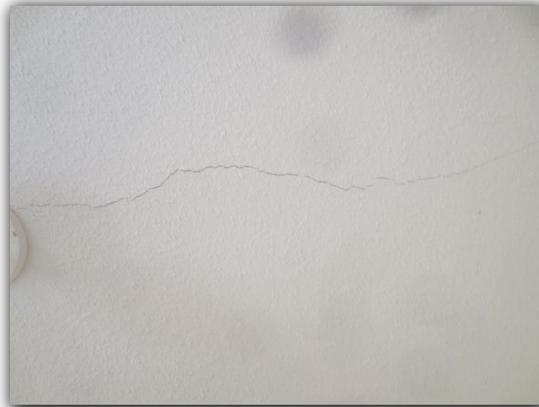
- Minor ceiling sheetrock cracks were observed in various locations . This condition is mainly cosmetic in nature and should be repaired as necessary.
-
- Possible water stain was observed on the ceiling in one location (master bedroom). The cause and remedy should be further evaluated and corrected as necessary.

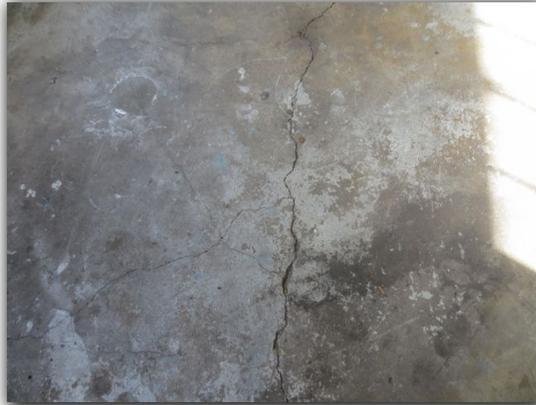
- Uneven, sloping and sagging floors were observed in various locations. This condition may indicate movement in the structure but is fairly typical of older pier and beam foundations and does not necessarily indicate foundation problems. Normal settling and movement in the structure of the piers and beams cause variations in the floors. These types of foundation and flooring systems can be adjusted with shims which can level the floors. This should be further investigated and repaired as necessary.
- Some cracking of the garage concrete floor finish was observed. This is usually a normal function of the curing of the concrete but the cracks should be monitored for any further movement in the future.

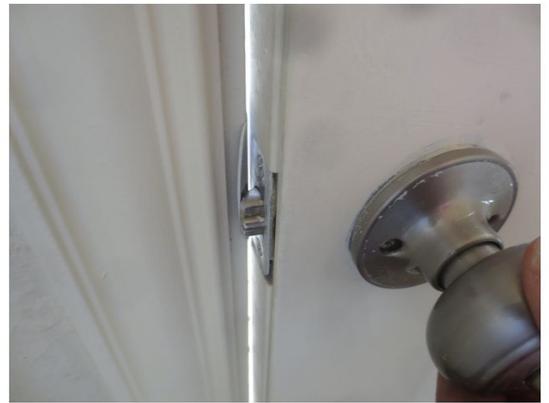
- Weather stripping around the rear exit door needs improvement.
- The door was not latching properly to the rear exterior .

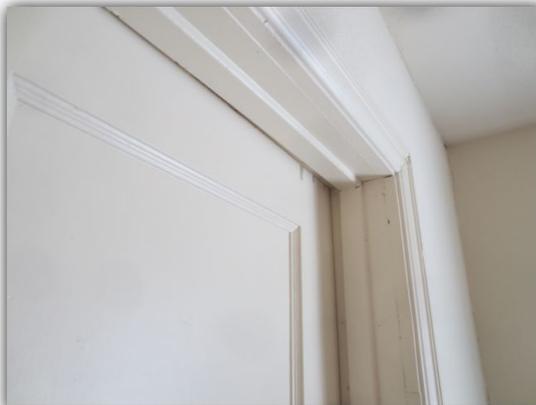
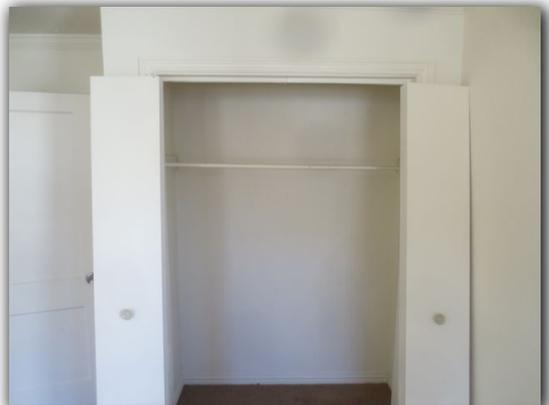
- The door was observed to be sticking to the master bath room .
- NE bedroom closet doors not installed.

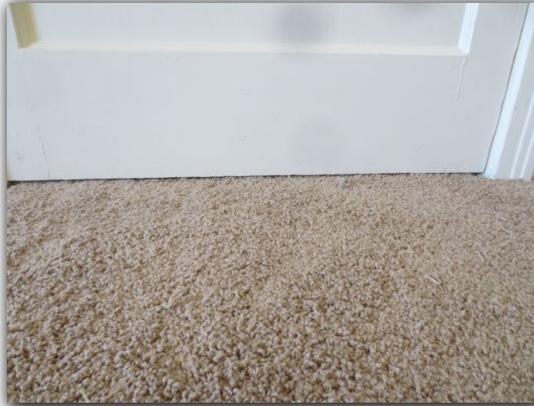
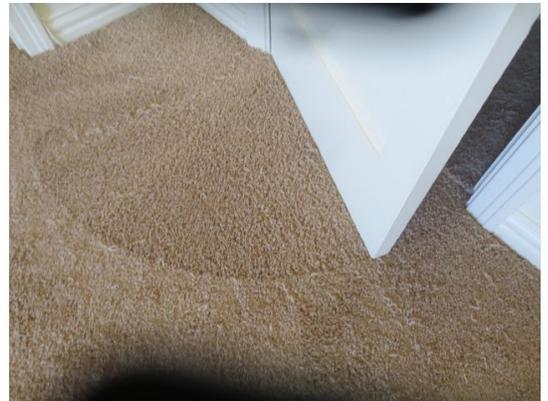
- The master bedroom closet, master bedroom, door was dragging the carpet. This should be repaired to allow proper ventilation of room and less wear on the carpet.

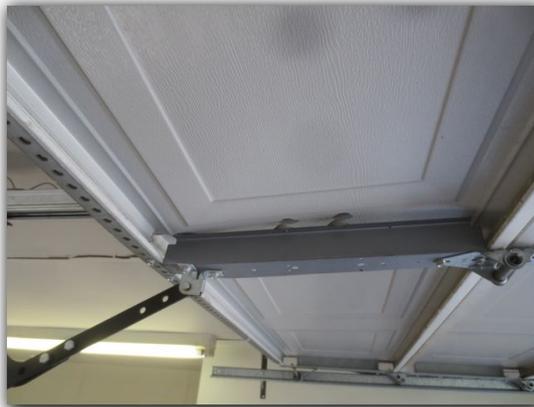
- When an automatic garage door opener is in use, the manual locks should be disabled or removed to prevent damage if a lock should be accidentally engaged before the garage door opener is activated.
- Some damage to the top panel on the garage overhead door was observed at the garage door opener arm connection. This should be repaired before continued use of the door opener to prevent further damage to the door.

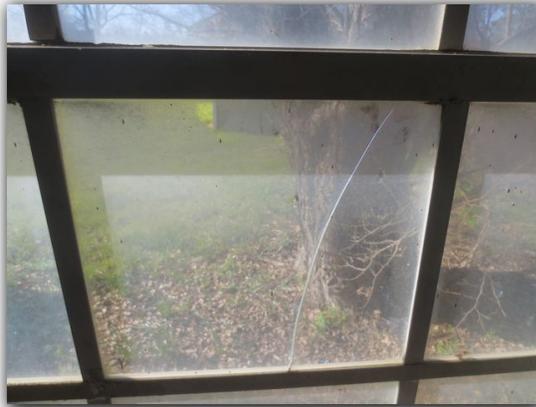
- Cracked and/or broken window glass was observed in the garage .
- Window will not stay in the open position in the garage . This should be further investigated and repaired as necessary.

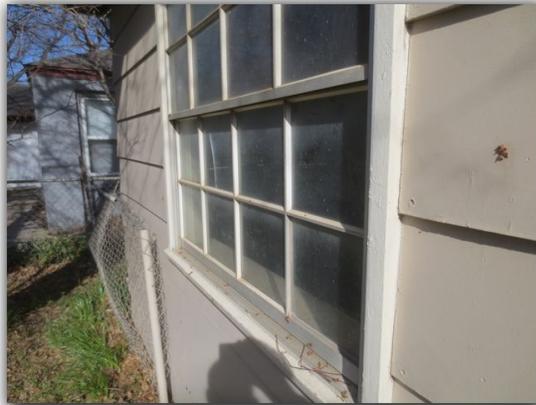
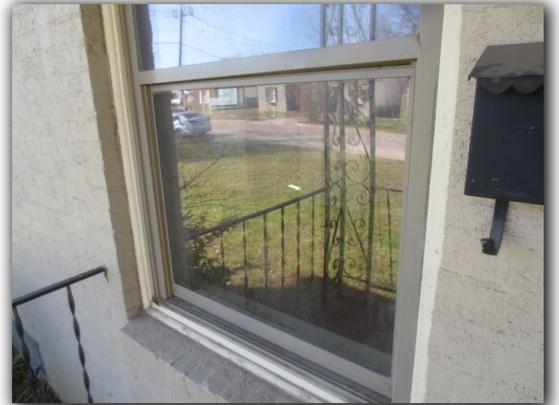
- One or more of the window screens were observed to be missing at the time of this inspection. The current owner should be consulted regarding any screens that may be in storage.

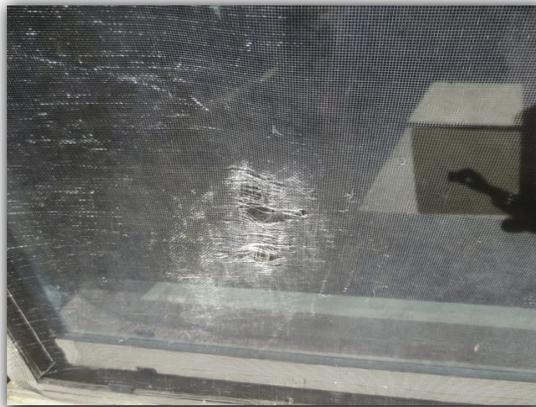
- One or more of the window screens were observed to be damaged at the time of this inspection.

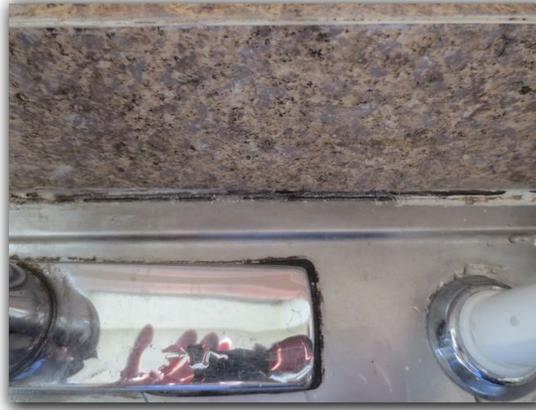
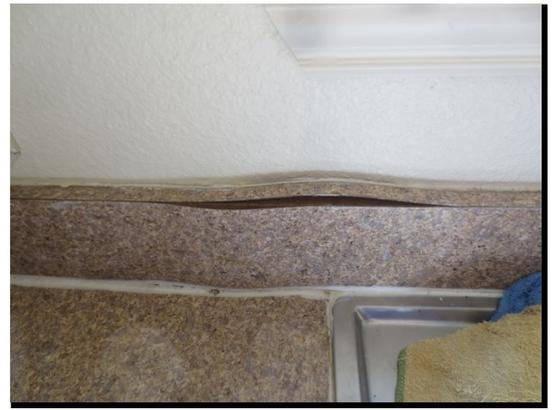
- Water damaged observed on kitchen counter backsplash and caulking needed.

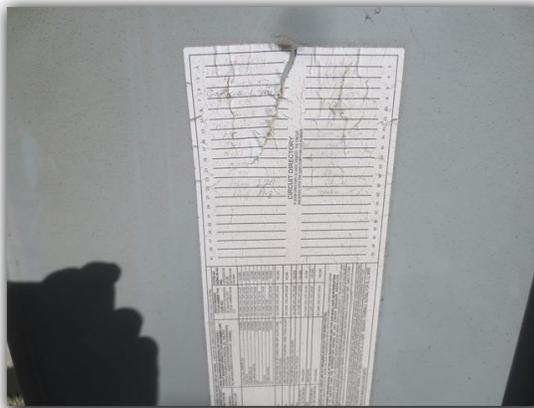
- The breakers (overcurrent devices) in the panel box are not properly/completely labeled. Without proper labeling it is difficult to know which breakers serve individual circuits in the house.

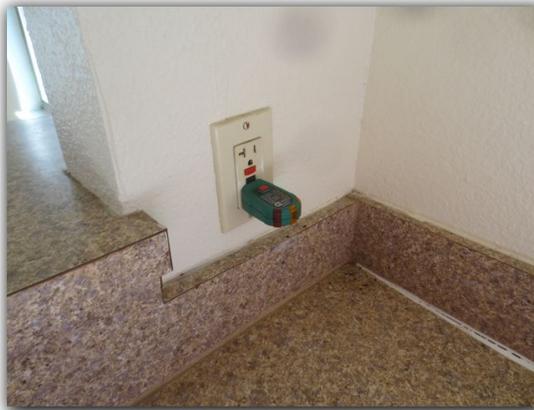
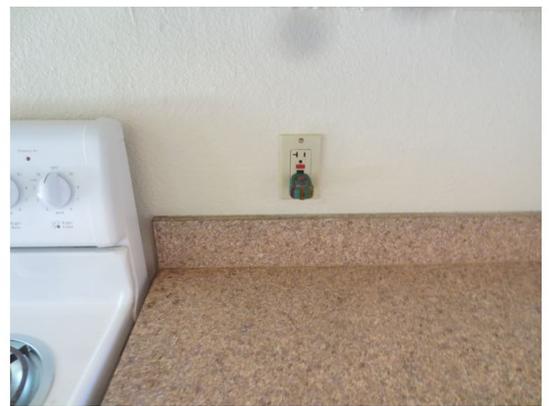
- Two ground fault circuit interrupter (GFCI) receptacle located in the kitchen were observed to be inoperative. This circuit and receptacle should be repaired and/or replaced.

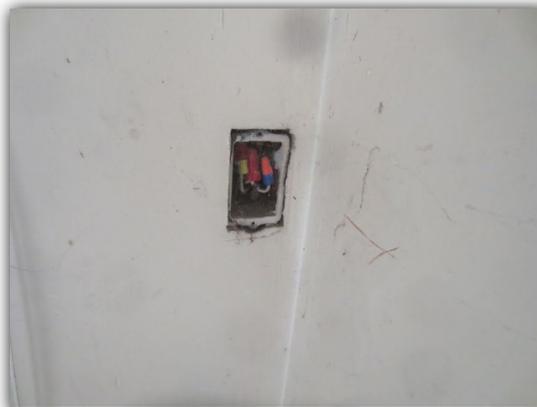
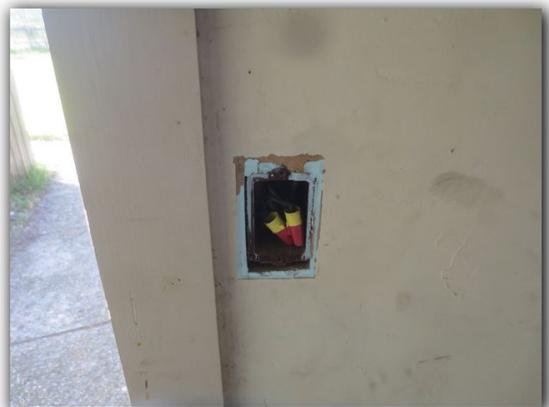
- Receptacles were observed to be missing cover plates in the attic, garage . The cover plates should be replaced for safety reasons.

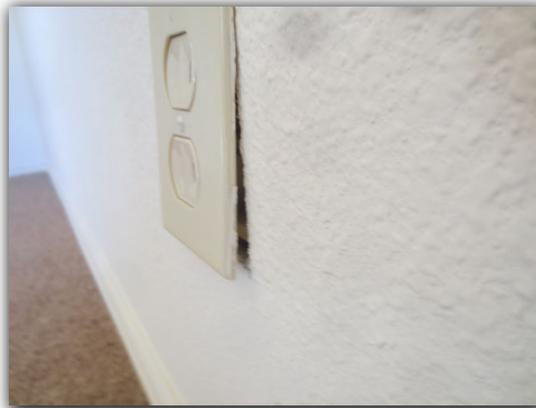
- Receptacles was observed to be loose at the wall mount in the master bedroom .

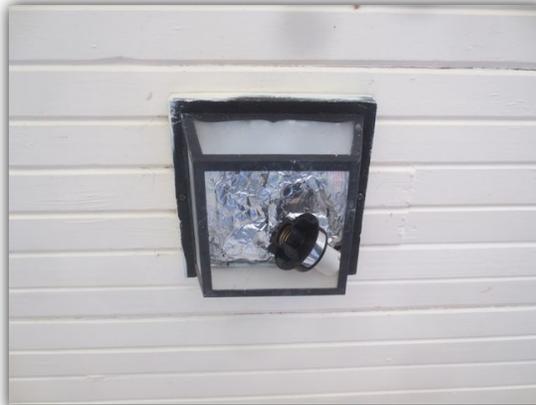
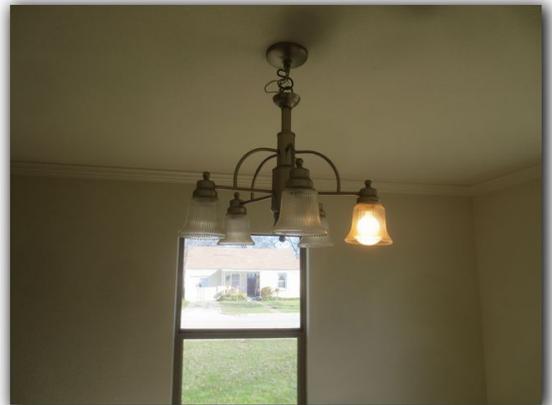
- The light fixture in the various locations were observed to be inoperative.

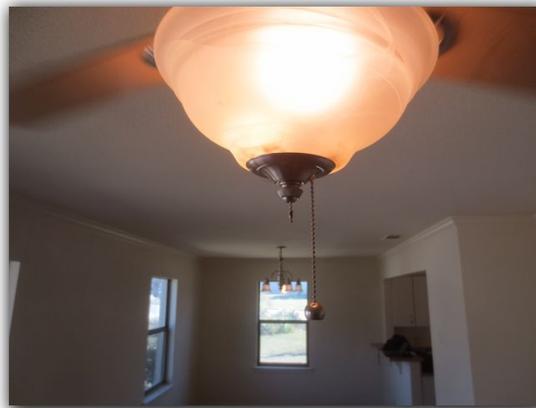
- Light fixture pull string was observed to be missing in the front living room .

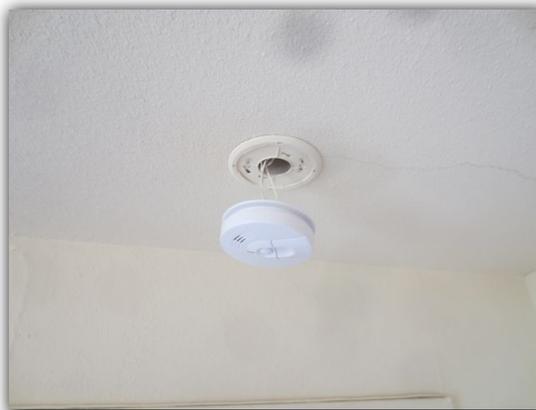
- Smoke Alarm in the NW bedroom was not responding when tested. This should be further investigated and repaired as necessary.
- Master bedroom smoke alarm wouldn't stay mounted to the ceiling.

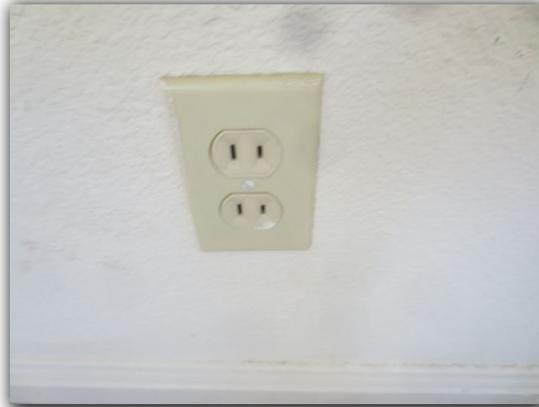
- Receptacle was observed to have an open ground connection in the master bedroom, NW bedroom, SW bedroom . This receptacle should be further investigated and repaired as necessary.

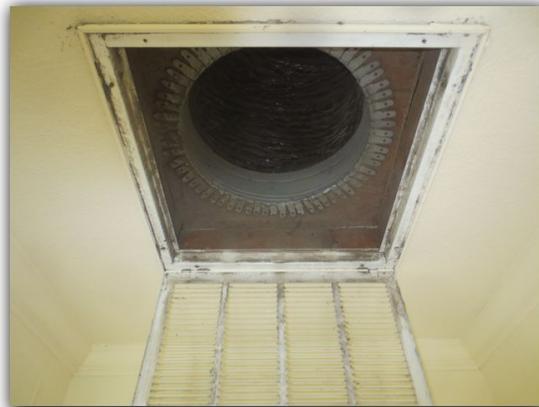
- The HVAC system air filter was observed to be missing and should be installed to provide for more efficient operation and to extend the life of the unit.

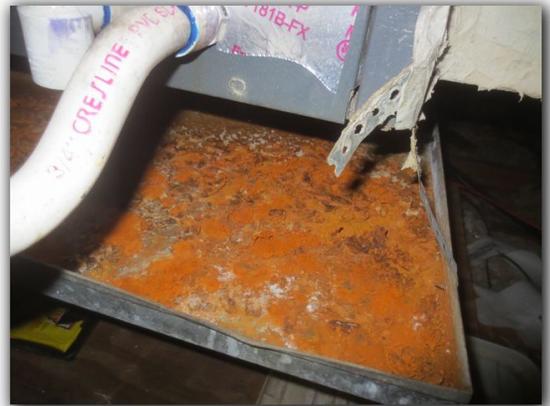
- The Texas Real Estate Commission recommends that the primary condensate drain line that runs off the indoor coils be insulated. By insulating the drain line, this will help prevent moisture from condensing on the exterior of the drain line and dripping onto the attic floors and/or ceilings of other surrounding structure.
- The emergency condensate drain pan under the coil housing has a rust build up. This indicates that the primary condensation drain line has been clogged in the past and the secondary drain has drained water into the pan. This should be further investigated by a qualified HVAC technician and repaired as necessary.

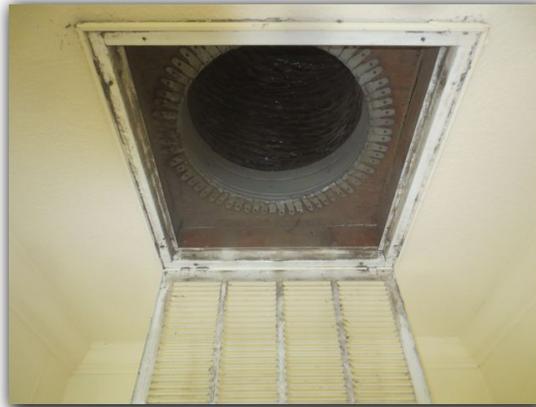
- Duct work in the house was observed to be dirty and full of lint and other air borne debris. A thorough cleaning of the ducts is recommended.

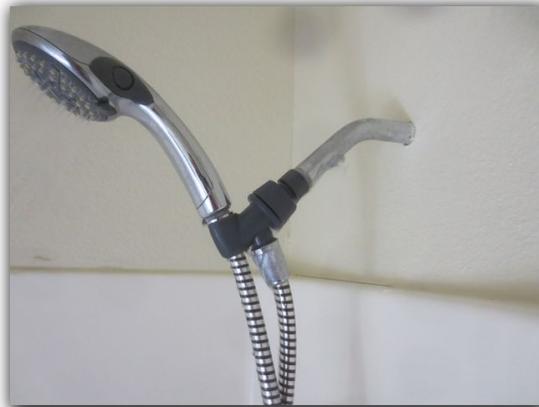
- The shower spout was observed to be leaking at the neck connection in the hallway bathroom .

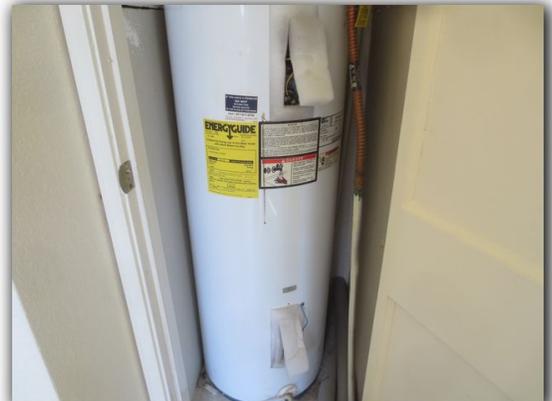
- There is no emergency pan installed under the water heater. Under today's residential building code standards, where water heaters or hot water storage tanks are installed in locations where leakage of the tanks or connection will cause damage, the tank or water heater should be installed in a galvanized steel pan. The pan should be drained by an indirect waste pipe to a suitably located indirect waste receptor or should extend to the exterior of the building and terminate not less than 6 inches and not more than 24 inches above the ground surface.
- Heating element access cover plates not installed.

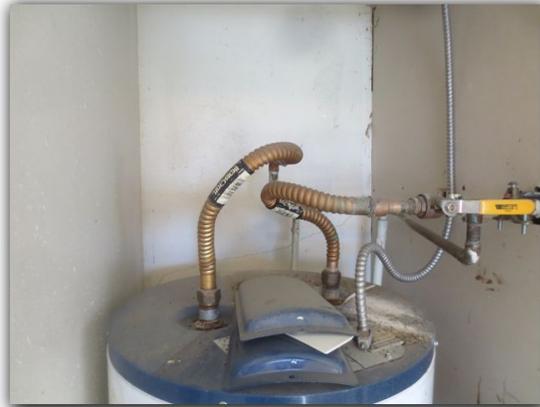
- Missing insulation on hot water line.

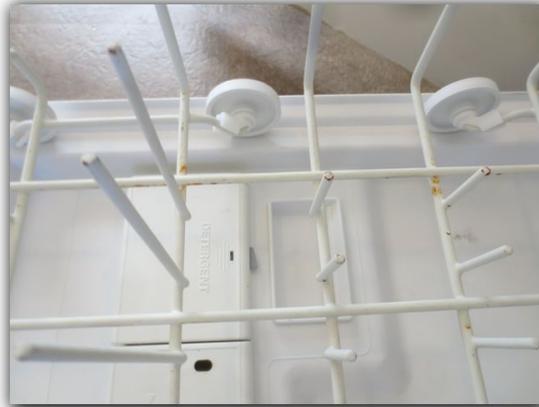
- Rust and/or corrosion was observed on the dishwasher interior rack.

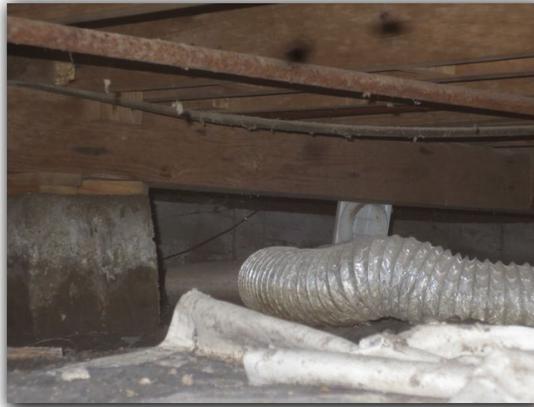
- The dryer observed to be venting into the crawl space area. Under current building standards the dryer should vent to the exterior of the structure. This condition should be corrected as necessary.
