**American Patriot
Home Inspection**

**1234 Anywhere St.
USA, TX 12345**

PROPERTY INSPECTION REPORT

By: Rodney W Collette, Lic #20449 03/26/2014
(Name and License Number of Inspector) (Date)

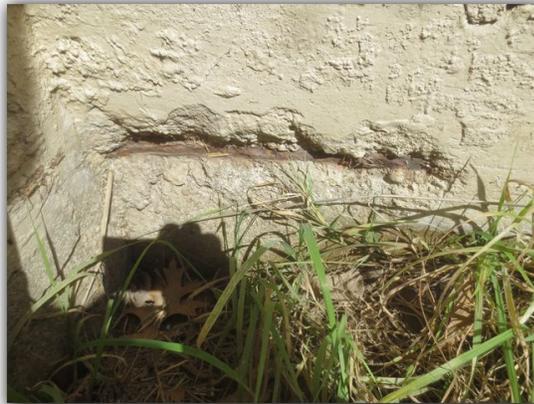
- Floor slopes and/or unlevelness observed.
- Foundation rebar is visible at the edge of the foundation beam on the south side of the house and needs to be properly covered.

- Substantial foundation cracking was observed in various locations. This implies that some structural movement of the building has occurred. The rate of movement cannot be predicted during a one-time inspection. A professional foundation repair company or a structural engineer should be consulted to further evaluate this condition.

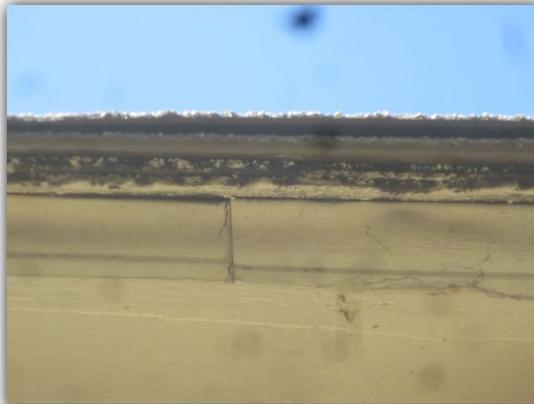
- Penetrations through roof need re-caulked to ensure no water intrusion.

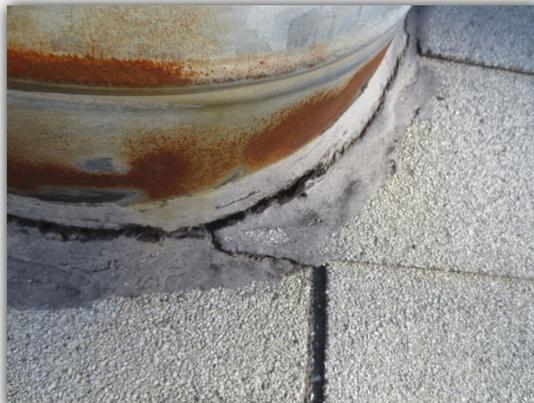
- The lead jack flashings on the roof need to be checked, reset and/or repaired as necessary. The lead jack flashing observed to be improperly damaged at one or more of the roof level plumbing vent pipes. The lead flashing should run full length of the vent pipe and turn down into the top of the vent pipe to help prevent water

intrusion at this point.

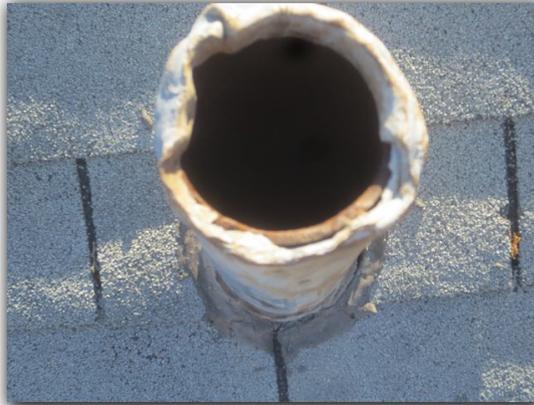
- Roof flashing was observed to be lifting and/or pulling loose in a couple of locations and should be re-secured to prevent moisture intrusion and damage to the underlying structure.

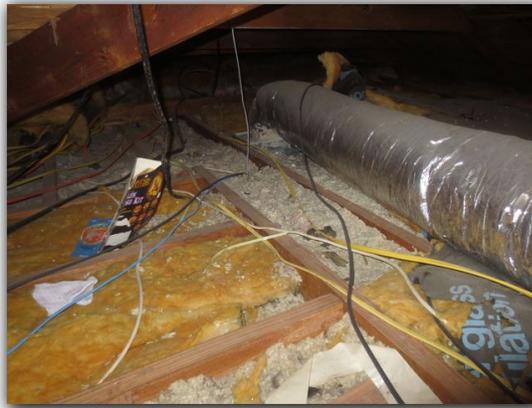
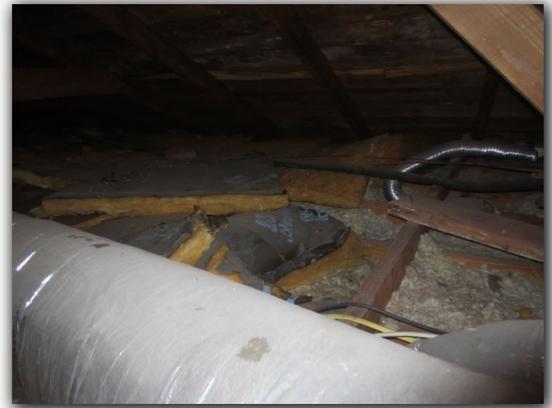
- Insulation improvements may be cost effective, depending on the anticipated term of ownership. Ten plus inches of insulation will provide an R-30 energy efficiency rating which would be adequate for this region of the country.
- The attic fold down door or the attic hatch should be insulated for better efficiency.
- The attic insulation has been placed over the fascia vents . This condition should be corrected to help improve the cross ventilation that is required for the attic space.

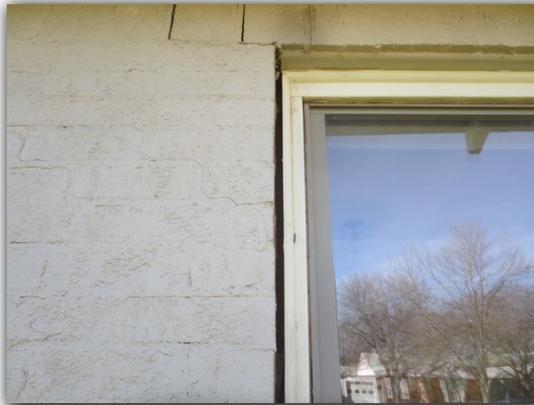
- Exterior wood trim was observed to have some deterioration and/or damage Various Locations. These areas should be repaired to prevent further moisture intrusion into the underlying structure.

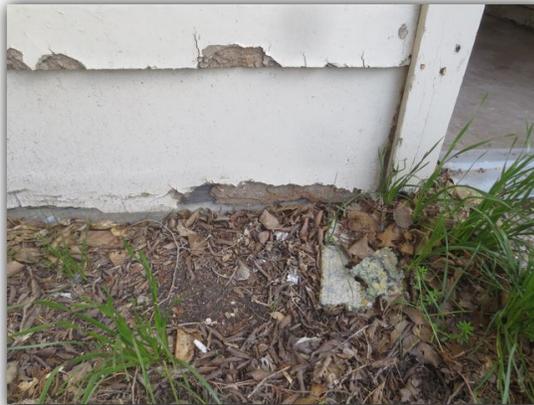
- Wood to soil contact at the base of the siding on garage and shed should be eliminated. Rotted or damaged siding that is uncovered should be repaired.
- The exterior masonry veneer has been painted which tends to hide visual defects and limits the inspector's visual observations.
- Larger than typical sheet rock cracks were noted [Various Locations](#). This condition could indicate greater than normal movement within the structure. This should be further investigated and repaired as necessary.

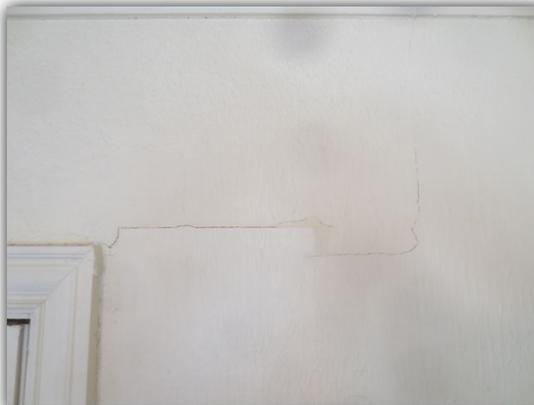
- Evidence of painting and patching to the interior finish and prior sheetrock repairs were observed in various locations .

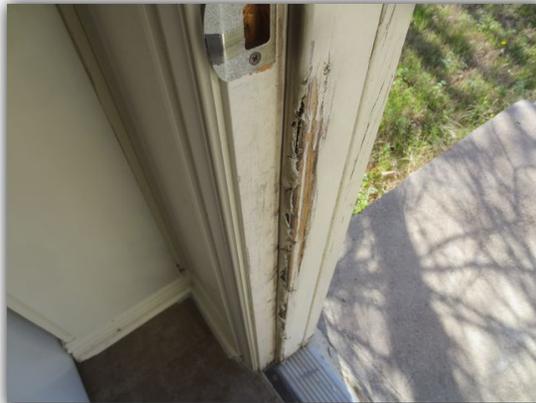
- Weather stripping around the rear exit door needs improvement.
- The door was not latching properly to the rear exterior .

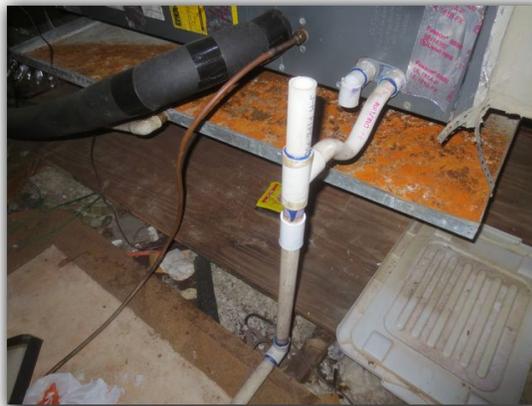
- The Texas Real Estate Commission recommends that the primary condensate drain line that runs off the indoor coils be insulated. By insulating the drain line, this will help prevent moisture from condensing on the exterior of the drain line and dripping onto the attic floors and/or ceilings of other surrounding structure.
- The emergency condensate drain pan under the coil housing has a rust build up. This indicates that the primary condensation drain line has been clogged in the past and the secondary drain has drained water into the pan. This should be further investigated by a qualified HVAC technician and repaired as necessary.

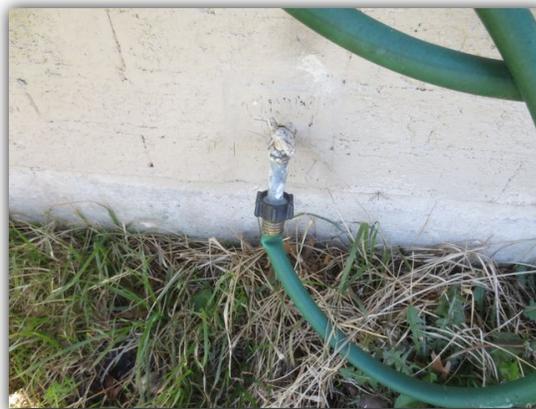
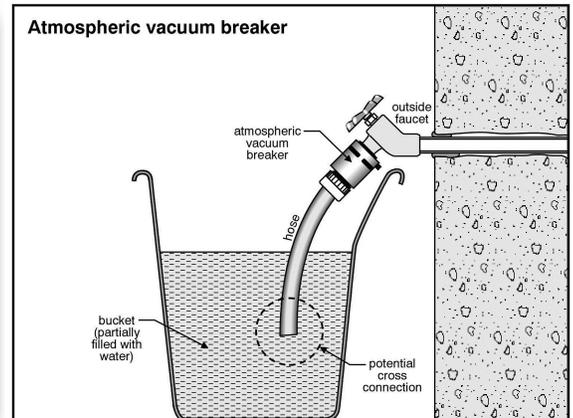
- There were no back-flow or anti-siphon devices (vacuum breakers) located at the outside water hose bibs (faucets). These devices were not required at the time this house was built but may be added to existing bibs if so desired.
- All exterior hose bibs (faucets) and supply piping should be properly insulated from freezing.

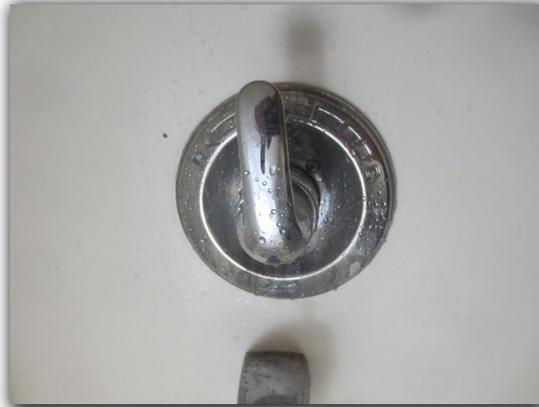
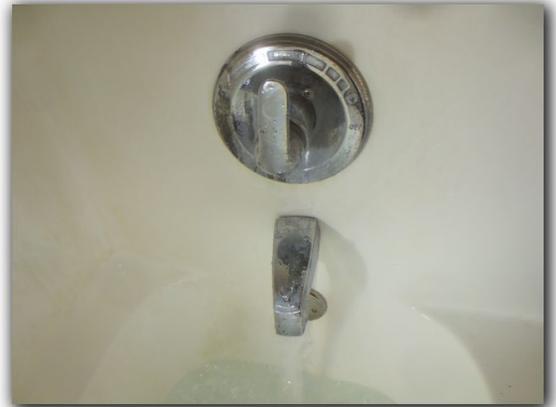
- The shower spout was observed to be leaking at the neck connection in the hallway bathroom .

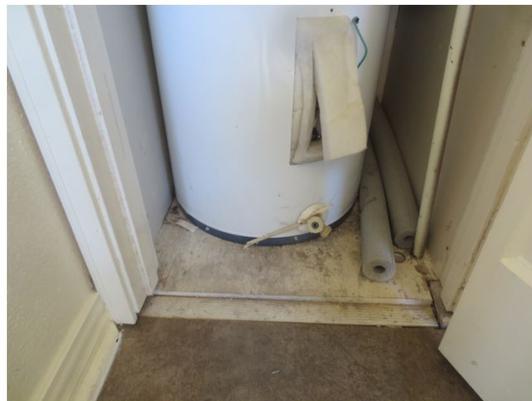
- There is no emergency pan installed under the water heater. Under today's residential building code standards, where water heaters or hot water storage tanks are installed in locations where leakage of the tanks or connection will cause damage, the tank or water heater should be installed in a galvanized steel pan. The pan should be drained by an indirect waste pipe to a suitably located indirect waste receptor or should extend to the exterior of the building and terminate not less than 6 inches and not more than 24 inches above the ground surface.
- Heating element access cover plates not installed.

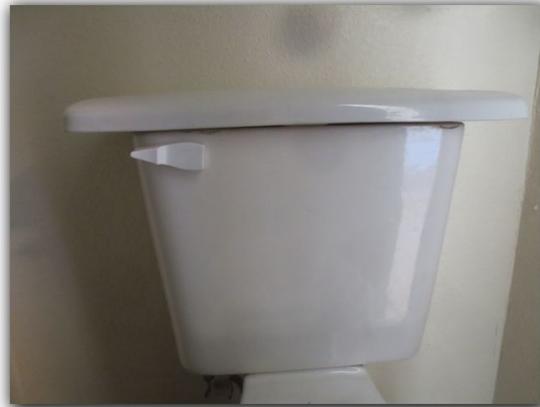
- Master bath toilet tank lid was incorrect size.

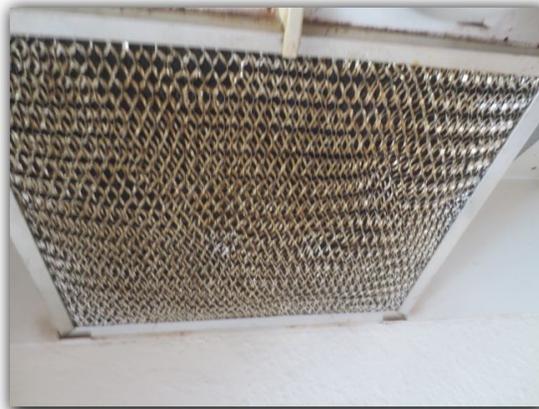
- Range exhaust vent filter dirty.

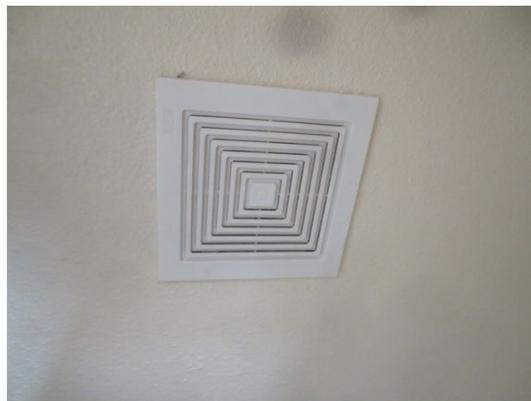
- Exhaust vent fan in the master bath room was inoperative at the time of this inspection.
